REAL COST OF RETROFITTING

Analysis of office block retrofit costs and viability

APRIL 2025

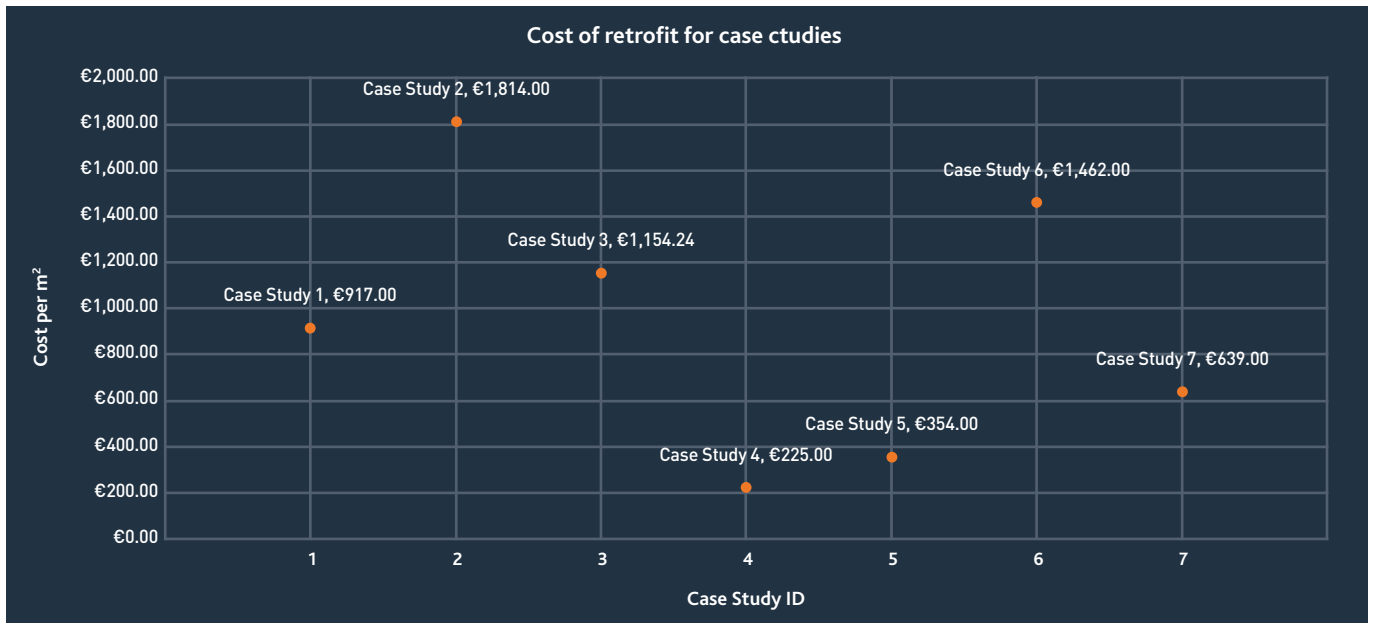
FIGURE 3: Cost per square metre for case studies used in this research.

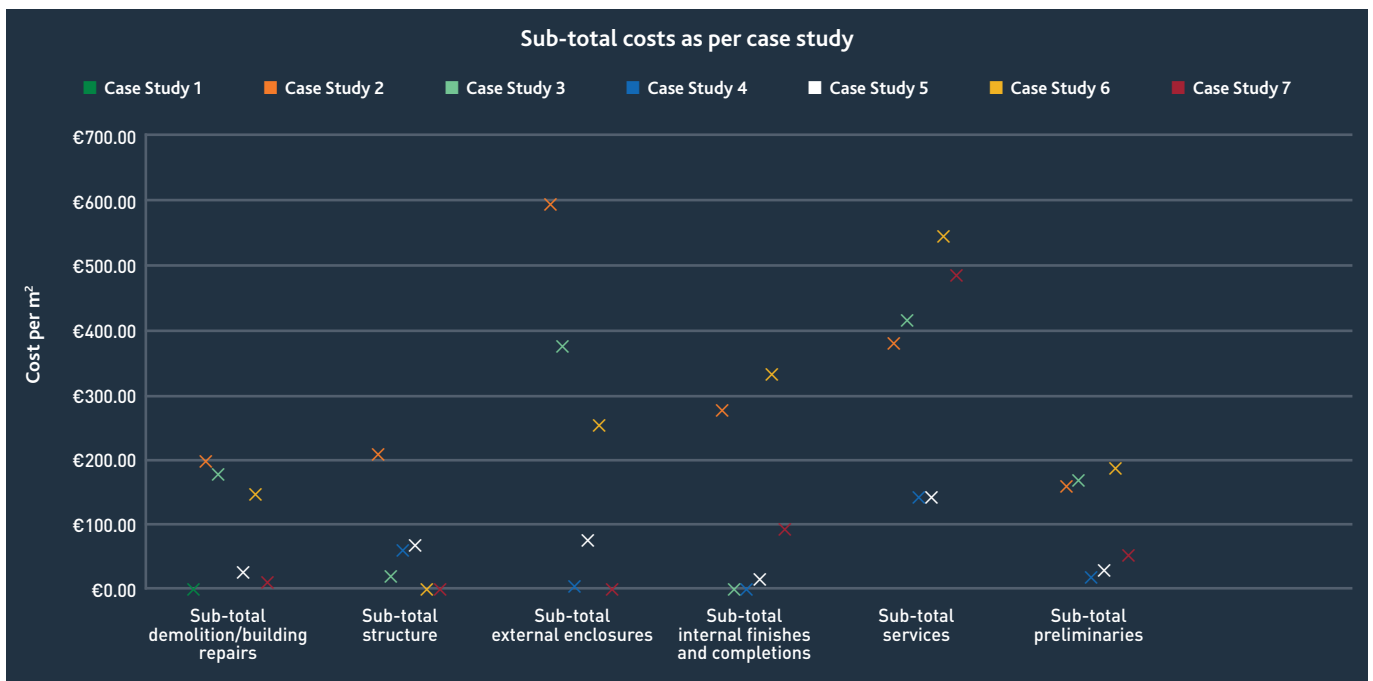
FIGURE 4: Cost per square metre of sub-total costs.
